Sound Arbor LLC  
25920 132<sup>nd</sup> St. SE  
Monroe, WA 98272  
360-217-7535

**EXHIBIT # 68.1**

**Re:** Air spade excavation to explore root depth and location

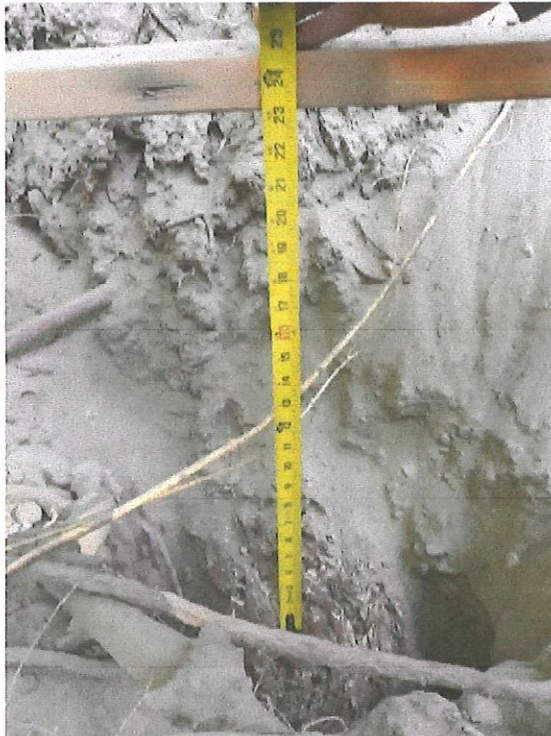
The air spade excavation revealed the first 12-14 inches of the soil around the trunk to be fill dirt from a much earlier time, evidenced by the high quantity of rocks, bricks, metal pipes, and garbage. The trunk flare originated approximately 13 inches below grade. Once the initial fill dirt was excavated from around the west side of the trunk, the next 10 inches of soil I encountered was a clay hardpan layer. The air spade was completely ineffective in removing this hard clay. It was not at all the sandy soil I was expecting to find. Hand tools were required and used carefully to chip at the clay to expose the 14" buttress root growing toward the proposed foundation corner. I followed the buttress root for approximately 3 feet, where a 6-inch caliper root branched off and grew directly toward the proposed foundation footprint. This 6-inch root was measured at 26 inches below grade. This 6-inch root was traced for another foot, and no noticeable elevation change was found. Due to the extreme ineffectiveness of the air spade in the hard clay layer, my exploratory efforts were limited to tracing this one buttress root for a short distance. More exploration and clay chiseling would have provided a better map of the root system of this Douglas fir, however the question on structural root depth was answered. The topography of the site indicates a fill layer that extends 5 feet west of tree # 10 and drops in elevation approximately 2 feet. It is likely that the roots beyond this fill area are closer to the surface, as they are not covered with fill.

(TOP)  
Measurement of depth of large buttress root to grade. Notice the depth at which the trunk was buried with fill dirt.

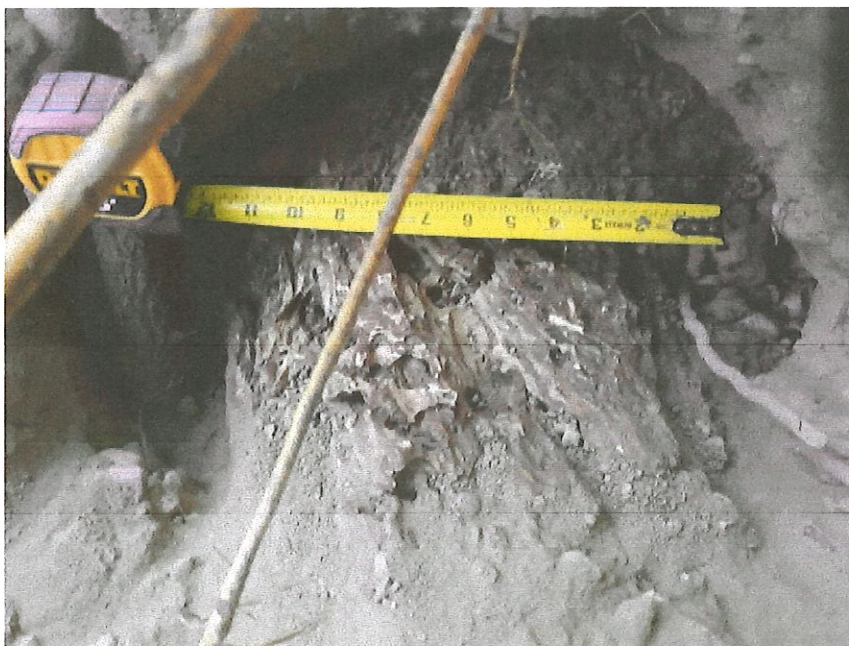
(BOTTOM)  
Caliper measurement of large buttress root near the base of the trunk

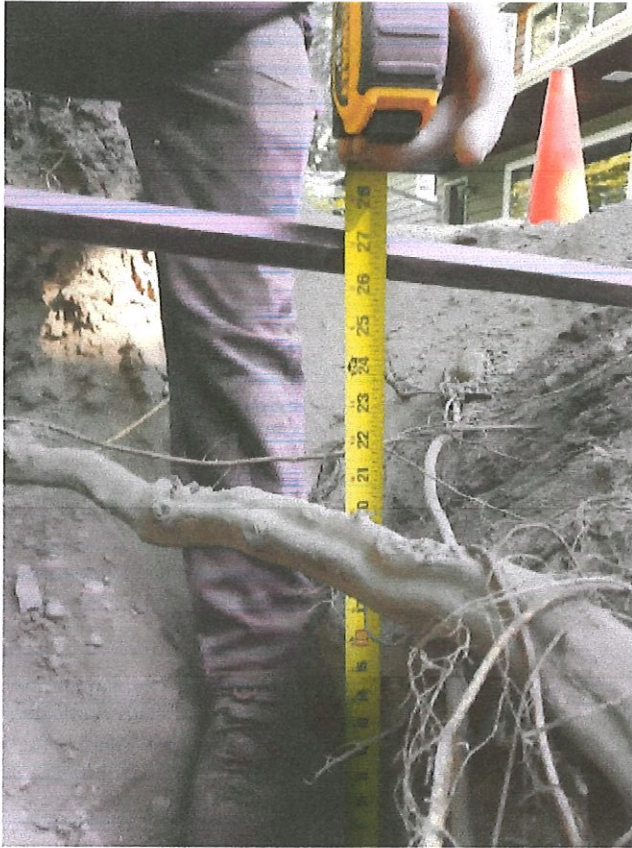
(TOP)  
Measurement of depth of 6-inch  
lateral root to grade.

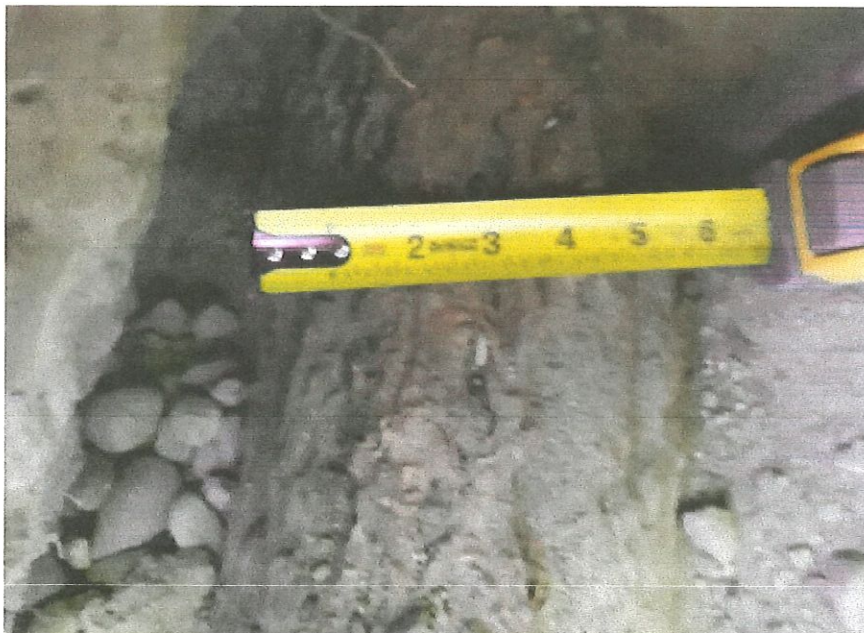
(BOTTOM)  
Caliper measurement of lateral  
root.
